PRIMERGY S60 ご使用前に

2002 年 1 月 富士通株式会社

PRIMERGY S60 Supplement

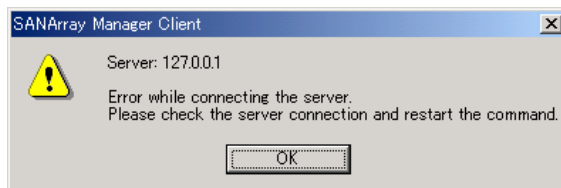
図 2-1

RAID 構成の変更(既存ロジカルドライブの削除)を行った後、OS のプラグアンドプレイ機能によりロジカルドライブがシステムから切り離された場合、以下のメッセージ(図 2-1、図 2-2)がいくつかポップアップすることがあります。この現象が発生した場合は、「OK」をクリックしてすべてのポップアップを閉じ、サーバ本体の再起動を行ってください。

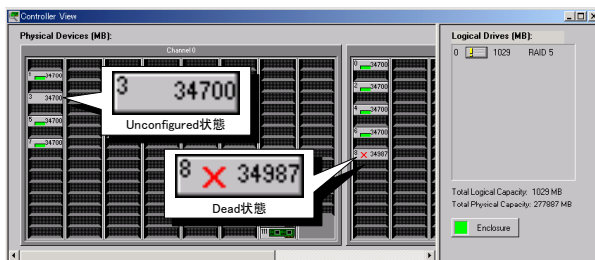
図 4-3 異常構成 ID 3 Dead(ホットスペア無し)

通常	本事象発生時
SAM Controller View	故障ハードディスクに対応した ID が「Dead」表示となる。	ホットスベア無しの構成 物理的にハードディスクが搭載されていない ID が「Dead」表示となる(例:図 4-3)。 ホットスベア有りの構成 「Dead」表示となっている ID が存在しない状態となる(例:図 4-6)。
ドライブ LED	故障ハードディスクに対応した ID の HDD STATUS LED(オレンジ)が点灯する。	故障ハードディスクに対応した ID の HDD STATUS LED(オレンジ)は点灯しない。

本事象に該当する場合、図 4-3のように Dead ハードディスクは ID の一番大きなハードディスクより一つ大きな ID (物理的に存在しない ID) に割当てられます。また、実際に Dead となったハードディスクは未使用のハードディスクと認識されるか、あるいは、表示されません。

1. SAMクライアントの **Controller View** ウィンドウで、実際にはハードディスクの存在しないスロットに **Dead** 状態のハードディスクが表示されていることを確認してください。
2. 次に、本製品には搭載されているが **Controller View** には表示されていない(または未使用状態となっている)ハードディスクの **ID** を確認してください。ここで確認した **ID** が、実際に故障しているハードディスクの **ID** です。
このとき、同故障ハードディスクの **HDD STATUS LED** は消灯(本来は故障時点灯)、また、ハードディスク故障によりクリティカル状態となったロジカルドライブを構成する他のハードディスクは、通常通り点滅します(**PRIMERGY S60 取扱説明書「1.3.1.2 ドライブLED」**参照)。

3. 本製品から、手順 2 で特定した故障ハードディスクを取り外してください。
4. 1 分程度待つてください。
5. 同じスロットに新しいハードディスクを取り付け、さらに 1 分程度待つてください。
6. SAMの **Administration** メニューから、**Scan Devices** を実行してください。ハードディスクが表示されていなかった場合は、新たに交換したハードディスクが正しい位置に表示されます。
7. 交換した新しいハードディスクのアイコンをダブルクリックし、「**Make Hot Spare**」ボタンをクリックしてください。ハードディスクが一時的にホットスペアディスクに設定されます。

8. サーバをシャットダウンした後、本製品の電源を落としてください。
9. 本製品の電源を入れてください。
10. サーバを起動し、**SAM**から交換したハードディスク(一時的にホットスペアディスクに設定したハードディスク)がリビルド状態であることを確認してください。
11. リビルドが完了したら、復旧完了です。

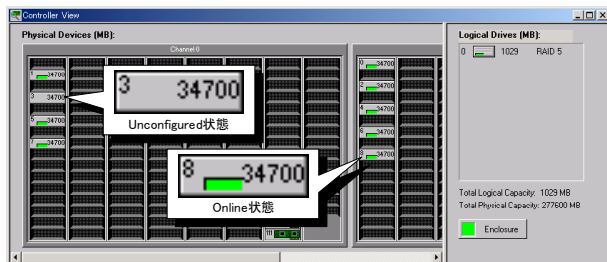
図 4-6 異常構成 ID3 Dead(ホットスペア有り&スタンバイリビルド後)

図 4-4の構成を例に説明します。この状態で、ID 3 のハードディスクが故障し、スタンバイリビルドが完了した場合、通常は図 4-5のような構成になります。本事象に該当する場合、図 4-6のように実際に Dead となったハードディスクは未使用のハードディスクと認識されるか、あるいは、表示されません。

ホットスペアリビルドが完了していることを確認したら、本製品には搭載されているが **Controller View** には表示されていない(または未使用状態となっている)ハードディスクの **ID** を確認してください。ここで確認した **ID** が実際に故障しているハードディスクの **ID** です。図 4-7はハードディスクをフル搭載している場合のハードディスクの搭載位置と **ID** の関係です。ハードディスクが表示されていない場合は図を参考に **ID** を特定してください。

2. 本製品から、手順2で特定した故障ハードディスクを取り外してください。
3. 1分程度待ってください。
4. 同じスロットに新しいハードディスクを取り付け、さらに1分程度待ってください。
5. **SAM** の **Administration** メニューから、**Scan Device** を実行してください。ハードディスクが表示されていなかった場合は、新たに交換したハードディスクが正しい位置に表示されます。
6. 交換した新しいハードディスクのアイコンをダブルクリックし、「**Make Hot Spare**」ボタンをクリックしてください。ハードディスクがホットスペアディスクに設定されます。
7. 以上で完了です。

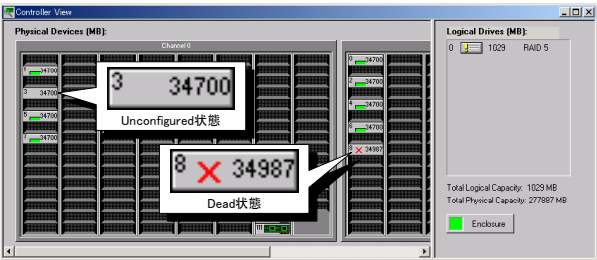
Figure 5-3 Invalid Configuration ID3 Dead (No Hot-spare)

If the drive ID-3 failed with the configuration shown with Figure 5-1, the configuration should go to the configuration shown with Figure 5-2 normally. If this problem happened, the ID next to the biggest ID that no drive exists actually becomes Dead (Figure 5-3). Actually failed drive is marked as ‘Unconfigured’ or it is not displayed.

1. Ensure that Dead is marked at the ID that actually no drive exists, with SAM Client Controller View.
2. Determine the location and ID of actually failed drive. The failed drive ID is that it physically exists and it is not displayed (or displayed as Unconfigured) on the Controller View.

3. Remove the failed drive determined at procedure-2.
4. Wait for 60 seconds.
5. Insert a new drive to the same slot that the failed drive existed and wait for another 60 seconds.
6. Perform 'Scan Devices' from Administration menu of SAM Client. If the drive was not displayed at the ID is now displayed.
7. Double click the icon of the ID corresponding to the replaced drive and click [Make Hot Spare]. The drive becomes 'Hot Spare' temporarily.
8. Shut down the host server(s) and switch off the PRIMERGY S60
9. Switch on the PRIMERGY S60.
10. Start the host server(s) and the replaced drive becomes 'Rebuilding' status.
11. After the rebuild completion, the array is recovered properly.

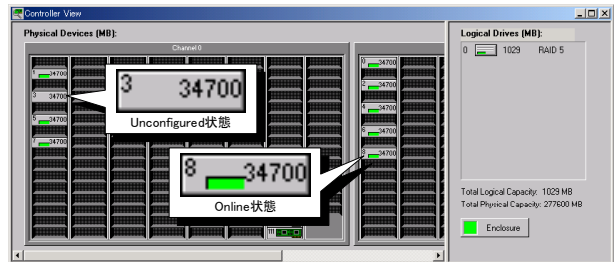
Figure 5-6 Invalid Configuration ID3 Dead (after hot-spare rebuild completion)

If this problem happened, actually failed drive is marked as 'Unconfigured', or it is not displayed. (Figure 5-6)

1. Ensure that the rebuild is completed automatically with SAM Client Controller View and SAM log.
2. Determine the location and ID of actually failed drive. The failed drive ID is that it physically exists and it is not displayed (or displayed as Unconfigured) on the Controller View.
For your information Figure 5-7 shows the IDs shown on the controller view.
3. Remove the failed drive determined at procedure-2.
4. Wait for 60 seconds.
5. Insert a new drive to the same slot that the failed drive existed and wait for another 60 seconds.
6. Perform 'Scan Devices' from Administration menu of SAM Client. If the drive was not displayed at the ID is now displayed.
7. Double click the icon of the ID corresponding to the replaced drive and click [Make Hot Spare]. The drive becomes 'Hot Spare'. Then the array is recovered.
