PRIMERGY S60 ご使用前に

2002 年 1 月 富士通株式会社

PRIMERGY S60 Supplement

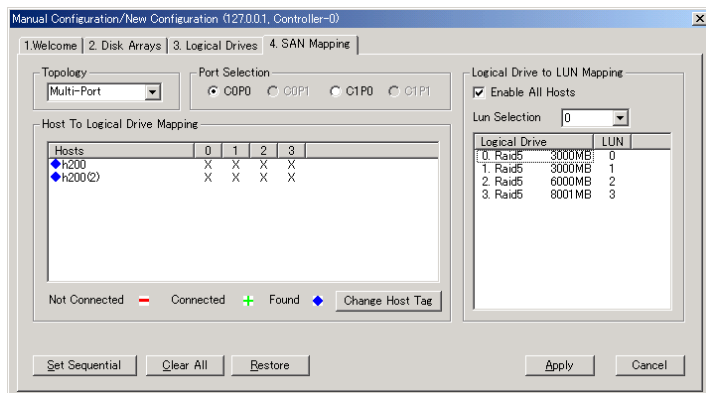
図 2-4 SAN Mapping タブ

いて、Logical Drive に対して LUN をマッピングする際は、図 2-4のように必ず LUN は0から順番にマッピングしてください。また、LUN が複数存在する場合は数字を飛ばすことなく0,1,2,3...というように番号を順番にマッピングしてください。

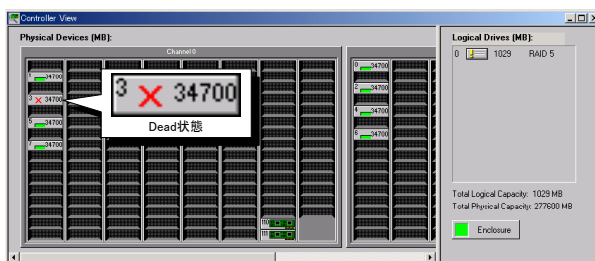
図 4-2 正常構成 ID3 Dead(ホットスペア無し)

図 4-1の構成を例に説明します。この状態で、ID 3 のハードディスクが故障した場合、通常は図 4-2のような構成になります。

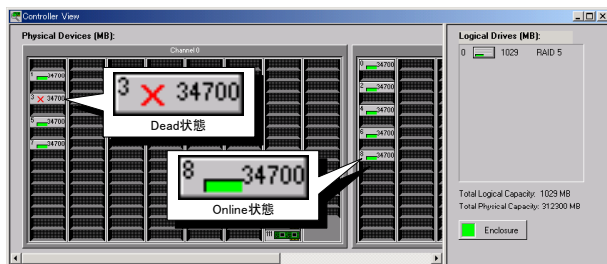
図 4-5 正常構成 ID3 Dead(ホットスペア有り&スタンバイリビルド後)

図 4-4の構成を例に説明します。この状態で、ID 3 のハードディスクが故障し、スタンバイリビルドが完了した場合、通常は図 4-5のような構成になります。本事象に該当する場合、図 4-6のように実際に Dead となったハードディスクは未使用のハードディスクと認識されるか、あるいは、表示されません。

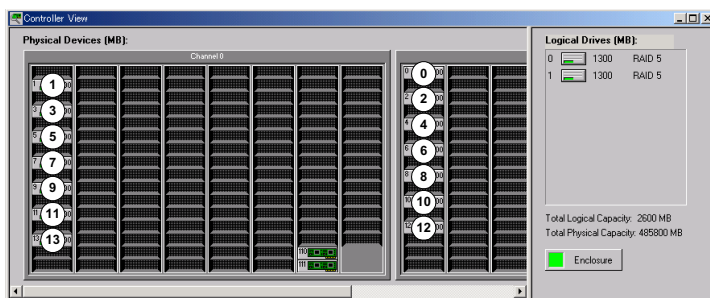
図 4-7 Controller View

1. SAMクライアントの **Controller View** ウィンドウで、実際にはハードディスクの存在しないスロットに **Dead** 状態のハードディスクが表示されていることを確認してください。
2. 次に、本製品には搭載されているが **Controller View** には表示されていない(または未使用状態となっている)ハードディスクの **ID** を確認してください。ここで確認した **ID** が、実際に故障しているハードディスクの **ID** です。
このとき、同故障ハードディスクの **HDD STATUS LED** は消灯(本来は故障時点灯)、また、ハードディスク故障によりクリティカル状態となったロジカルドライブを構成する他のハードディスクは、通常通り点滅します(**PRIMERGY S60 取扱説明書「1.3.1.2 ドライブLED」**参照)。

ホットスペアリビルドが完了していることを確認したら、本製品には搭載されているが **Controller View** には表示されていない(または未使用状態となっている)ハードディスクの **ID** を確認してください。ここで確認した **ID** が実際に故障しているハードディスクの **ID** です。図 4-7はハードディスクをフル搭載している場合のハードディスクの搭載位置と **ID** の関係です。ハードディスクが表示されていない場合は図を参考に **ID** を特定してください。

3. 本製品から、手順 2 で特定した故障ハードディスクを取り外してください。
4. 1 分程度待つてください。
5. 同じスロットに新しいハードディスクを取り付け、さらに 1 分程度待つてください。
6. SAMの **Administration** メニューから、**Scan Devices** を実行してください。ハードディスクが表示されていなかった場合は、新たに交換したハードディスクが正しい位置に表示されます。
7. 交換した新しいハードディスクのアイコンをダブルクリックし、「**Make Hot Spare**」ボタンをクリックしてください。ハードディスクが一時的にホットスペアディスクに設定されます。

2. 本製品から、手順2で特定した故障ハードディスクを取り外してください。
3. 1分程度待ってください。
4. 同じスロットに新しいハードディスクを取り付け、さらに1分程度待ってください。
5. **SAM** の **Administration** メニューから、**Scan Device** を実行してください。ハードディスクが表示されていなかった場合は、新たに交換したハードディスクが正しい位置に表示されます。
6. 交換した新しいハードディスクのアイコンをダブルクリックし、「**Make Hot Spare**」ボタンをクリックしてください。ハードディスクがホットスペアディスクに設定されます。
7. 以上で完了です。

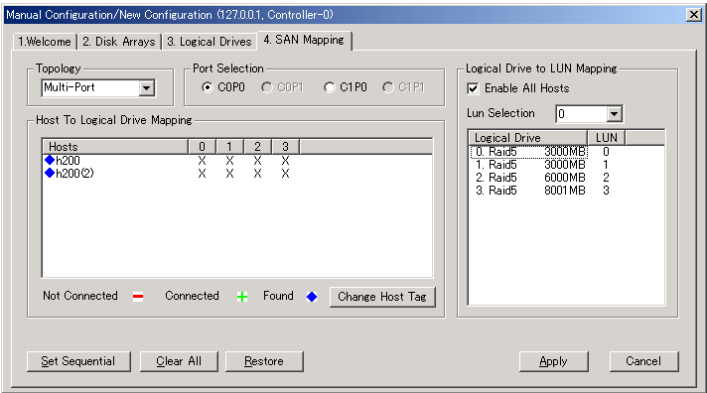
Figure 4-3 SAN Mapping tab (Manual Configuration)

On “Logical Drive to LUN Mapping” in “SAN Mapping” tab of SAM, assign the number to LUN in order from 0 like Figure 4-3. Also, if there are multiple LUN don’t skip number that is assigned to LUN.

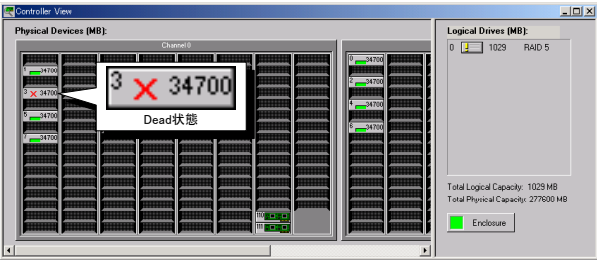
Figure 5-2 Normal Configuration ID3 Dead (No Hot-spare)

If the drive ID-3 failed with the configuration shown with Figure 5-1, the configuration should go to the configuration shown with Figure 5-2 normally. If this problem happened, the ID next to the biggest ID that no drive exists actually becomes Dead (Figure 5-3). Actually failed drive is marked as ‘Unconfigured’ or it is not displayed.

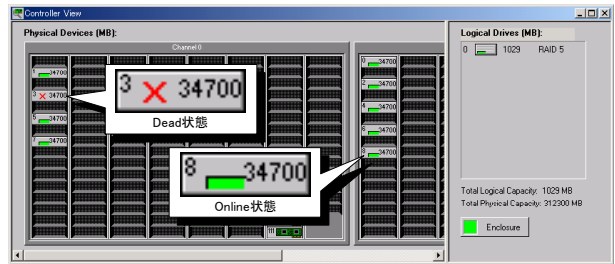
Figure 5-5 Normal Configuration ID3 Dead (after hot-spare rebuild completion)

If the drive ID-3 failed with the configuration shown with Figure 5-4, the configuration should go to the configuration shown with Figure 5-5 normally after the rebuild completion.

If this problem happened, actually failed drive is marked as 'Unconfigured', or it is not displayed. (Figure 5-6)

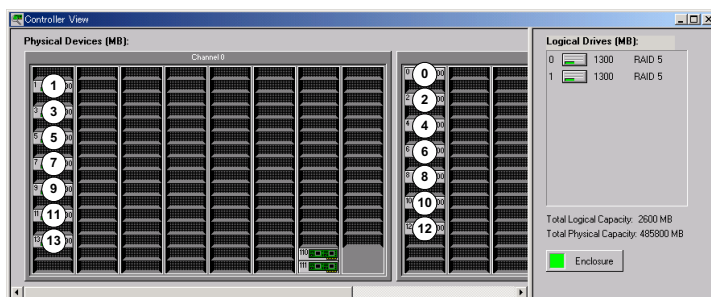
Figure 5-7 Controller View

1. Ensure that Dead is marked at the ID that actually no drive exists, with SAM Client Controller View.
2. Determine the location and ID of actually failed drive. The failed drive ID is that it physically exists and it is not displayed (or displayed as Unconfigured) on the Controller View.

3. Remove the failed drive determined at procedure-2.
4. Wait for 60 seconds.
5. Insert a new drive to the same slot that the failed drive existed and wait for another 60 seconds.
6. Perform 'Scan Devices' from Administration menu of SAM Client. If the drive was not displayed at the ID is now displayed.
7. Double click the icon of the ID corresponding to the replaced drive and click [Make Hot Spare]. The drive becomes 'Hot Spare' temporarily.
8. Shut down the host server(s) and switch off the PRIMERGY S60
9. Switch on the PRIMERGY S60.
10. Start the host server(s) and the replaced drive becomes 'Rebuilding' status.
11. After the rebuild completion, the array is recovered properly.
