GP5-148ご使用前に(重要)

このたびは、弊社製品をお買い求めいただきまして、まことにありがとうございます。本書は、本製品に添付されている「SCSIアレイコントローラカード GP5-148 (AcceleRAID 352) 取扱説明書」の記述を補足しております。本製品をご使用前に必ずお読みください。

Notes on Use of RAID Card GP5-148

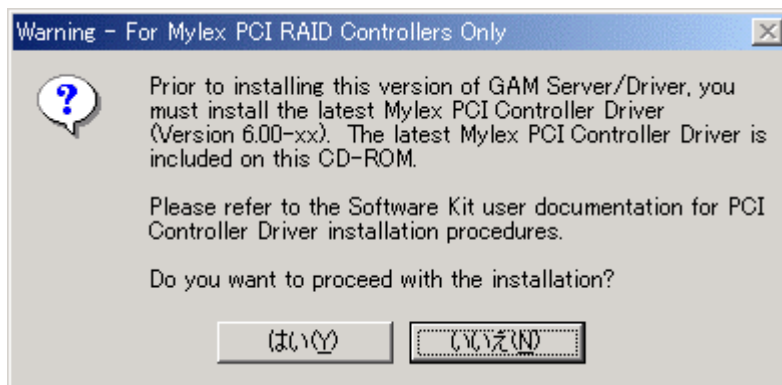
5. Global Array Manager(GAM)のインストールにおいて、SETUP.EXEの実行直後に、以下のウィンドウが表示されます。「はい」をクリックしてインストールを続行してください。

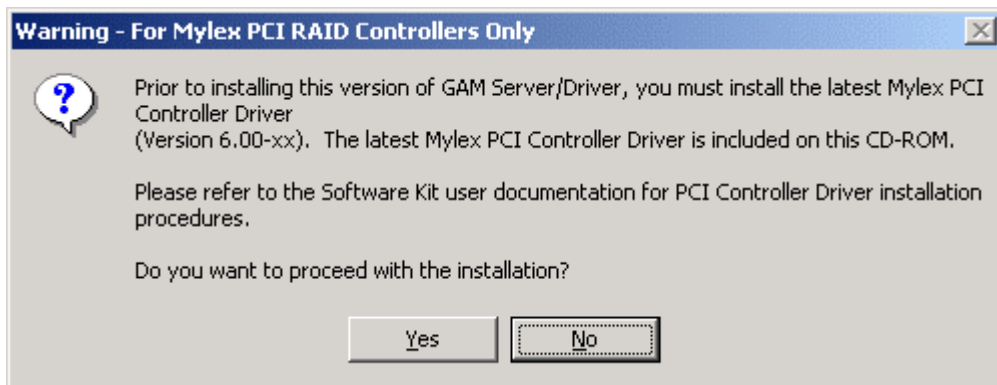
5. Following window will be shown after executing SETUP.EXE in Global Array Manager installation. Click "Yes" to continue the installation.
